# RP2350

PCN 28 – A4 stepping

Update of RP2350 silicon to A4 stepping.

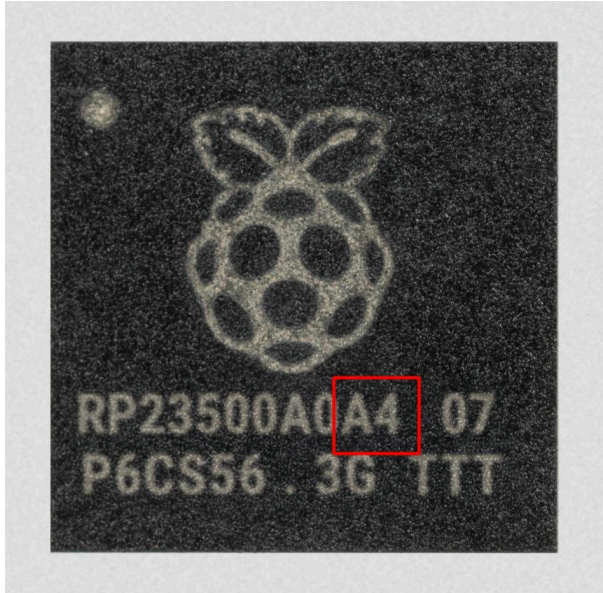
The new product can be distinguished by examination of the chip. The part number printed on the top of the device will have the suffix **A4** , as shown in the image below.
